# Bulk Carrier - Mineral Honshu

**Stop corrosion.** Without blasting.

Reference Master, Capt. Volodymyr Miroshnychenk - M.V. Mineral Honshu

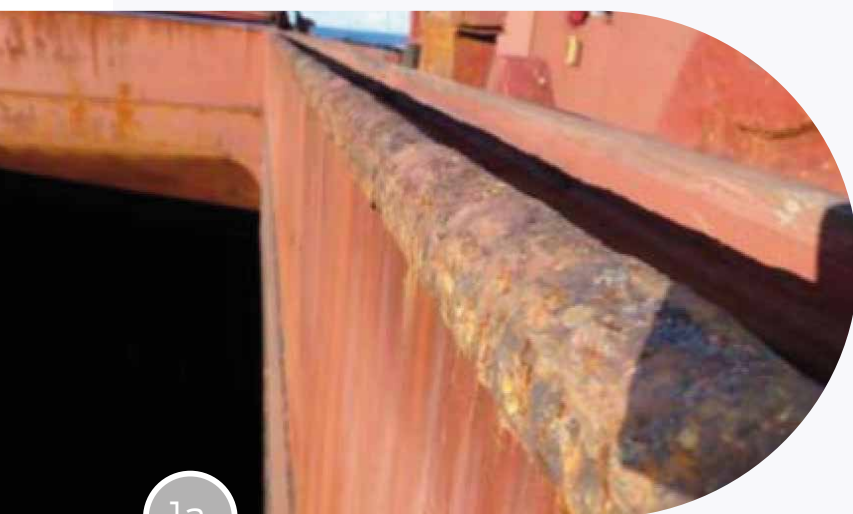
1a.

**Before** application of  
nC Corrosion Passivator - Coaming.

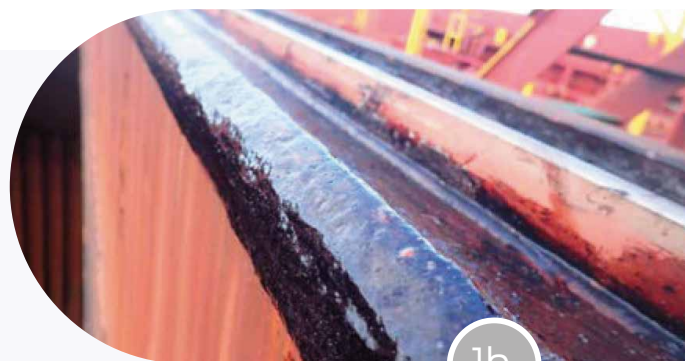
1b.

**After** application of  
nC Corrosion Passivator.

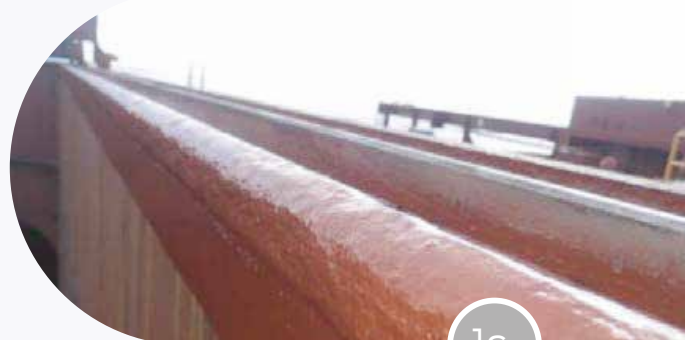
1c.

**After** application of top coat.

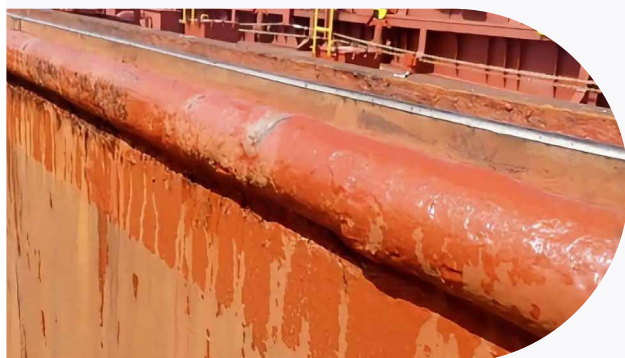
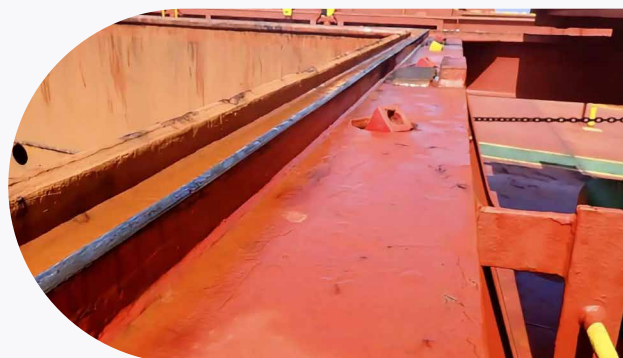
**Feedback after 6 months.** No increase or spread of rust in areas coated with two layers of nC Corrosion Passivator and one layer of top coat.

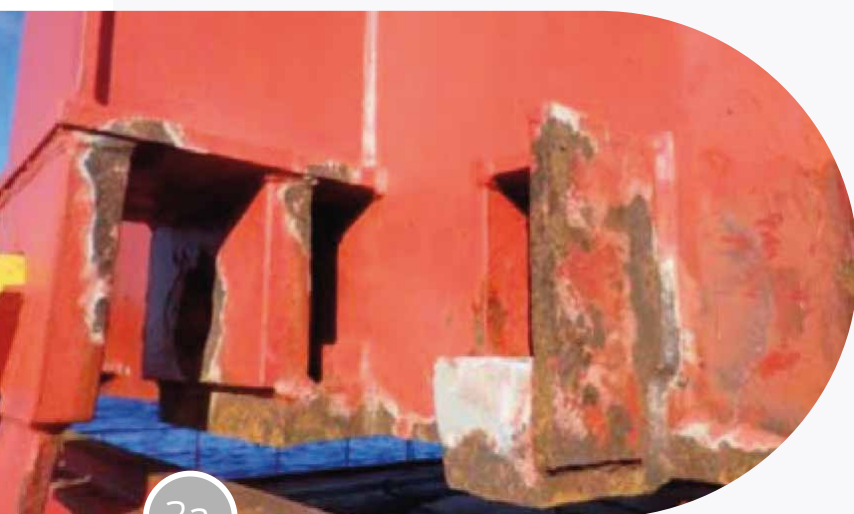
2a.

**Before** application of  
nC Corrosion Passivator - Coaming.

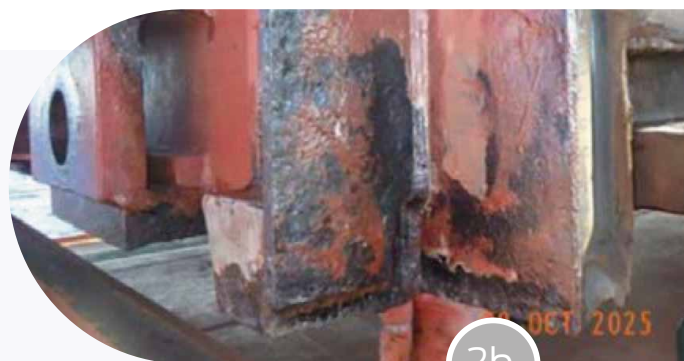
2b.

**After** application of  
nC Corrosion Passivator.

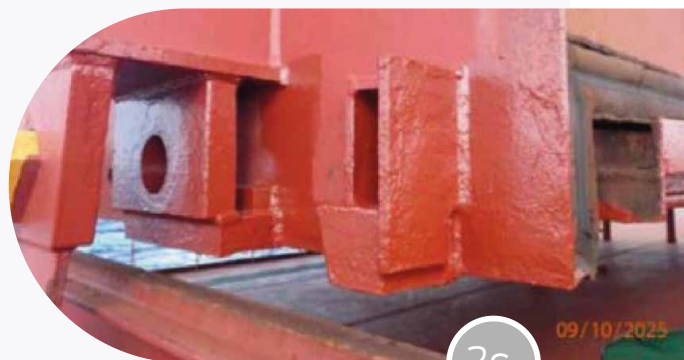
2c.

**After** application of top coat.

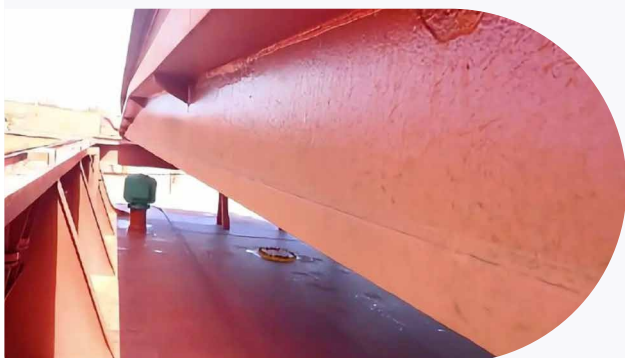
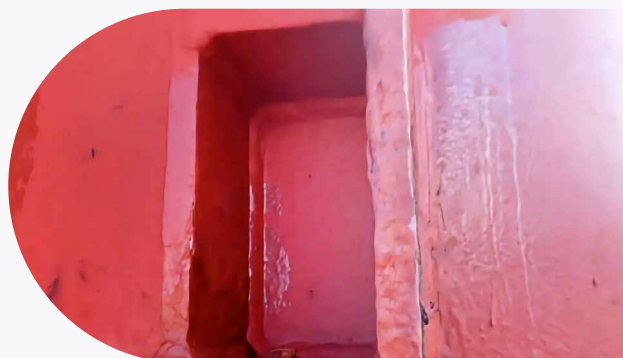
**Feedback after 6 months.** No increase or spread of rust in areas coated with one layer of nC Corrosion Passivator and one layer of top coat.

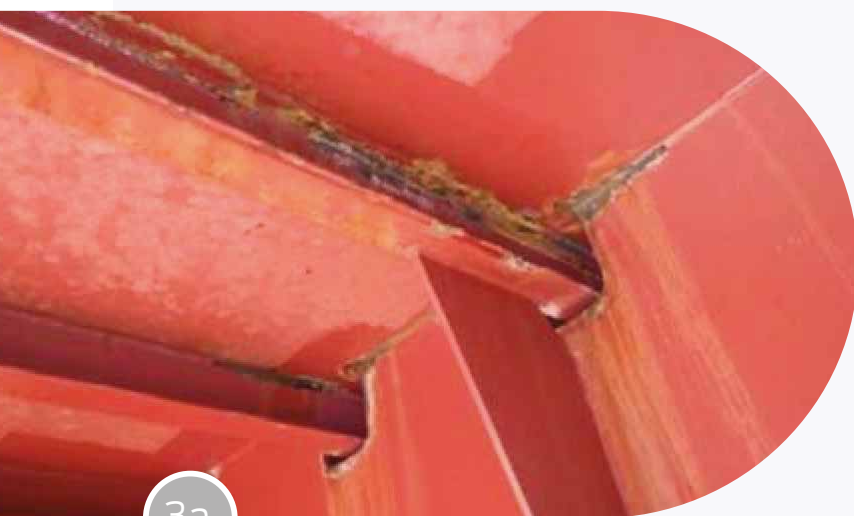
3a.

**Before** application of nC Corrosion Passivator - Welds hatch cover.

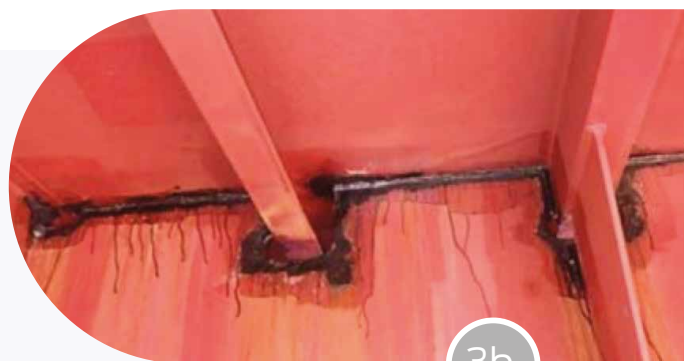
3b.

**After** application of nC Corrosion Passivator.

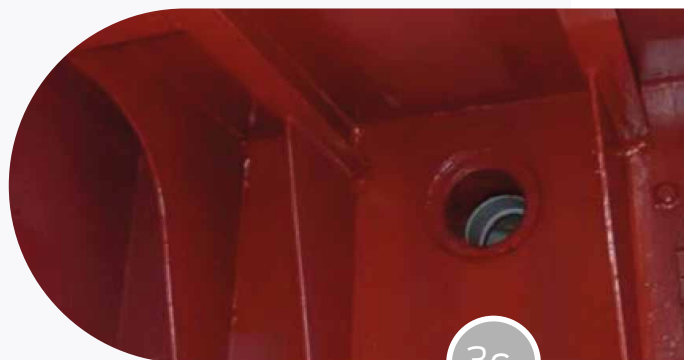
3c.

**After** application of top coat.

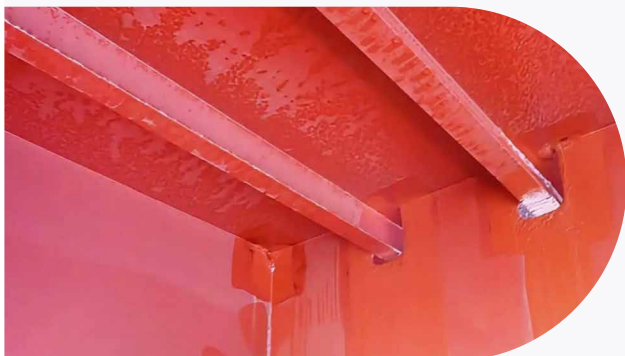
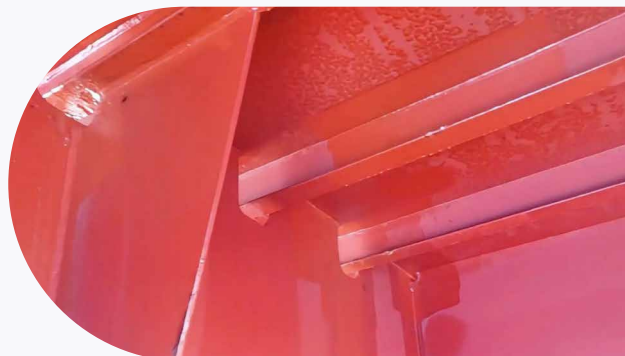
**Feedback after 6 months.** No increase or spread of rust in areas coated with one layer of nC Corrosion Passivator and one layer of top coat.

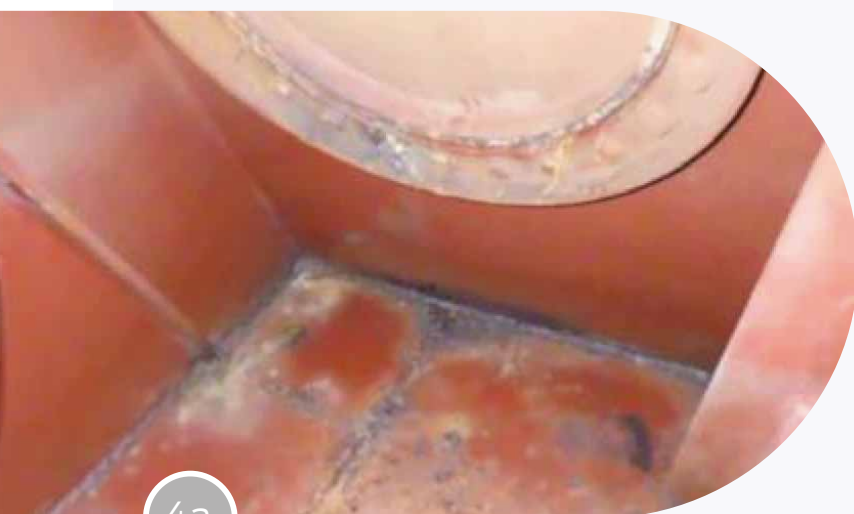
4a.

**Before** application of  
nC Corrosion Passivator - Lower stool.

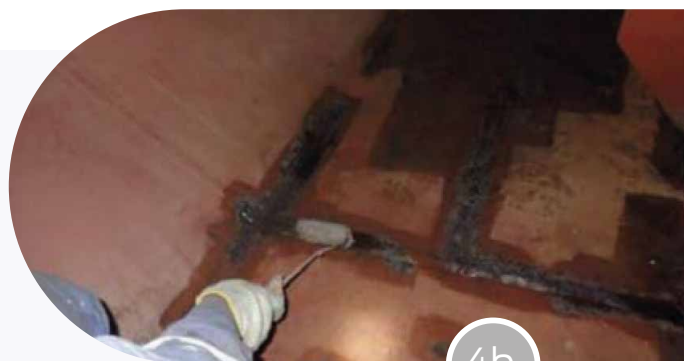
4b.

**After** application of  
nC Corrosion Passivator.

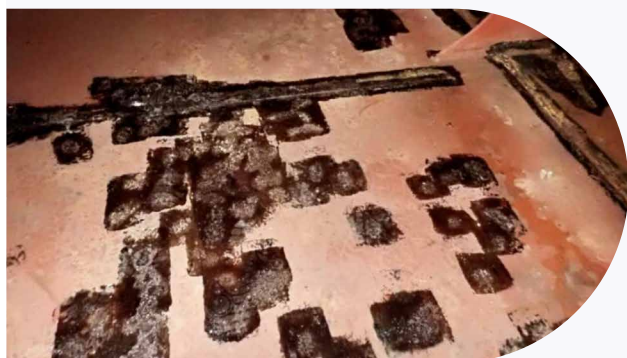
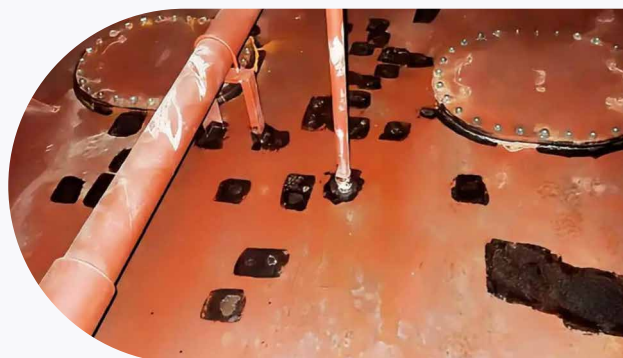
**Feedback after 6 months.** No increase or spread of rust in areas coated with one layer of nC Corrosion Passivator.

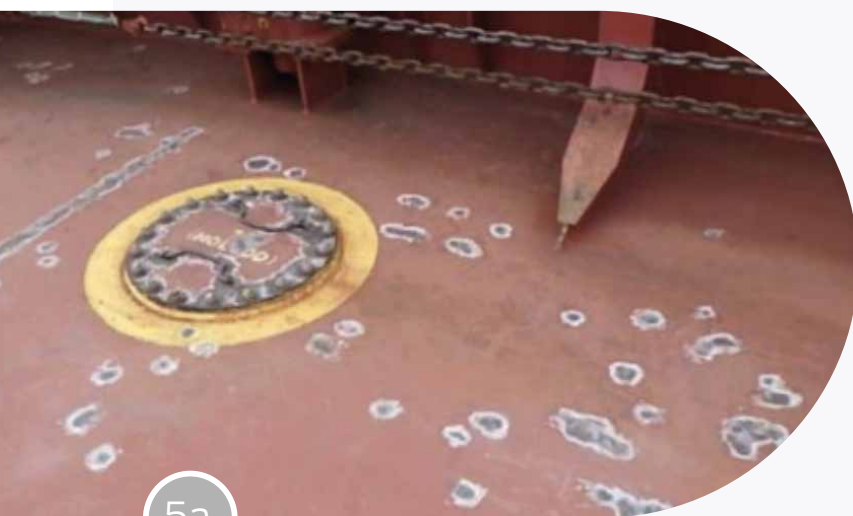
5a.

**Before** application of  
nC Corrosion Passivator - On deck.

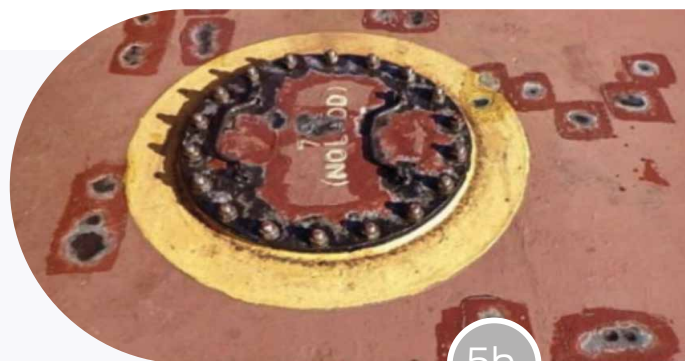
5b.

**After** application of  
nC Corrosion Passivator.

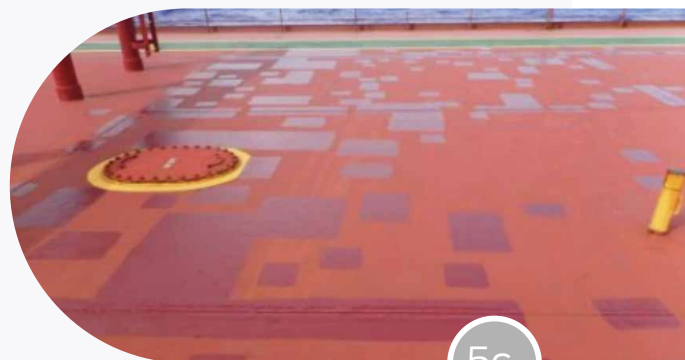
5c.

**After** application of top coat.

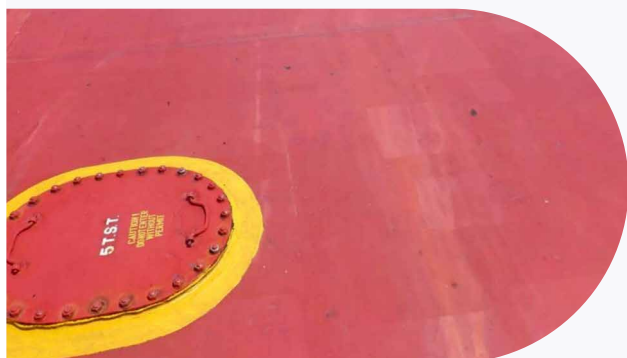
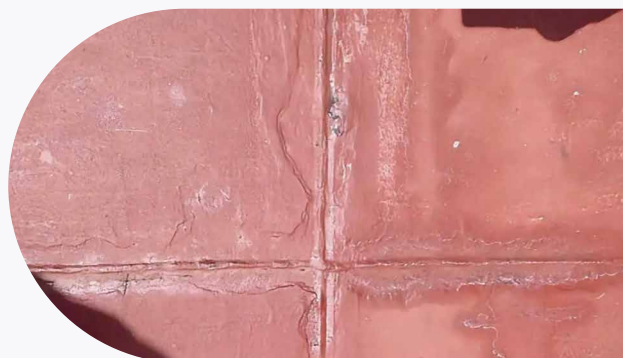
**Feedback after 6 months.** No increase or spread of rust in areas coated with one layer of nC Corrosion Passivator and one layer of top coat.

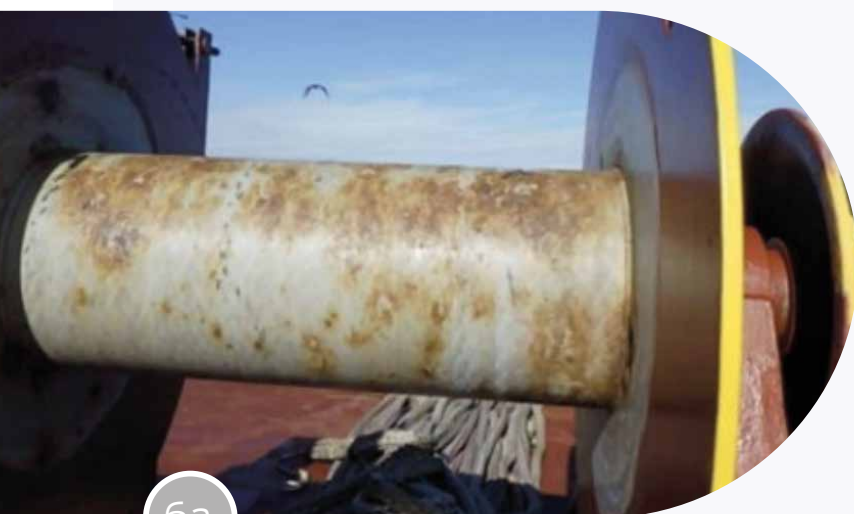
6a.

**Before** application of  
nC Corrosion Passivator - Winch.

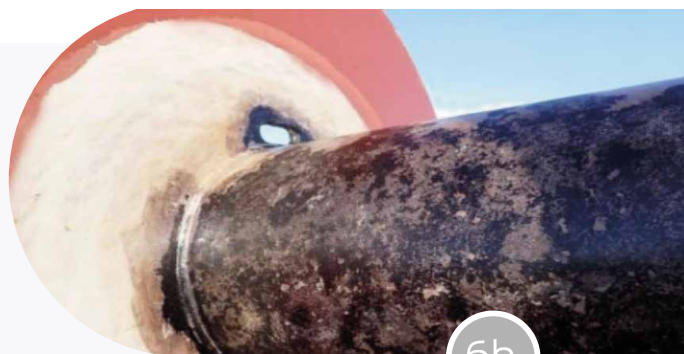
6b.

**After** application of  
nC Corrosion Passivator.

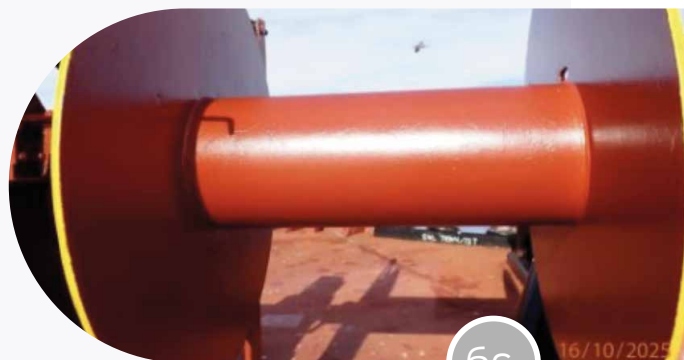
6c.

**After** application of top coat.

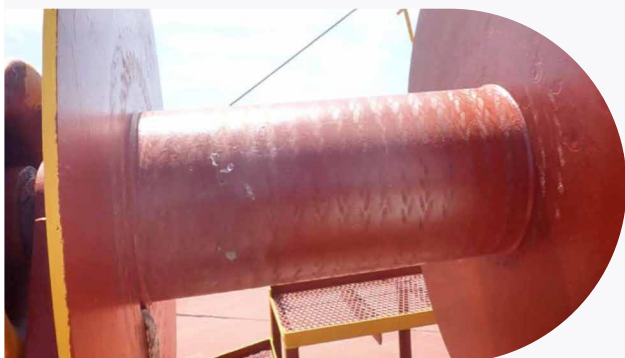
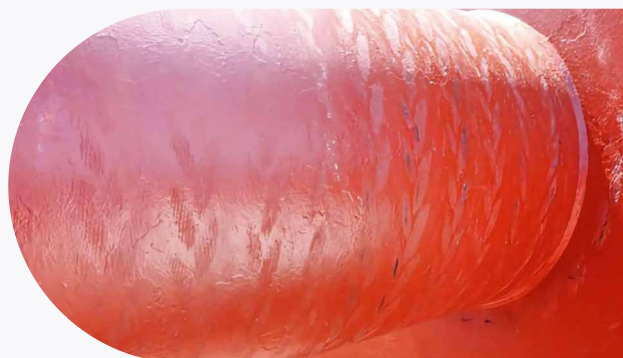
**Feedback after 6 months.** No increase or spread of rust in areas coated with one layer of nC Corrosion Passivator and one layer of top coat.
